CASE STUDY APPLICATION

HOTEL CORRIDOR REPLACEMENT

DEDICATED OUTDOOR AIR SYSTEM

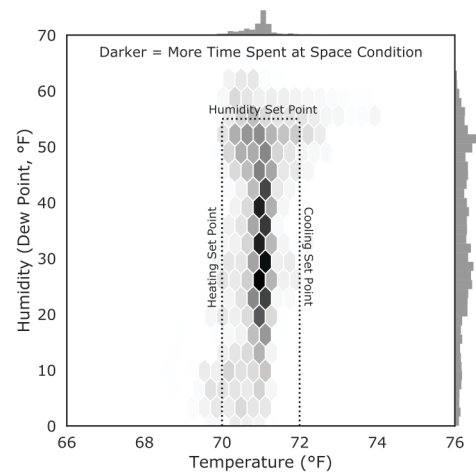
Space Conditions Relative to Set Points

Performance data over three months since commissioning in mid-September reveal a successful outcome. While operating 24/7 at 100% outside air:

- Space temperatures always remained within 1°F of the set points
- Space humidity (dew point temperatures) did not exceed 3°F of the set point over 99% of the active cooling period
