CASE STUDY APPLICATION

hotel corridor replacement

PRODUCT SPOTLIGHT

dedicated outdoor air system

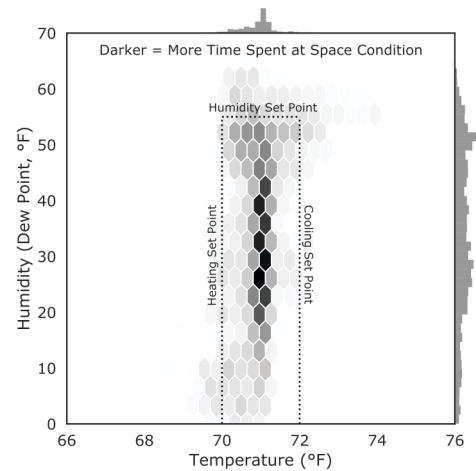
Space Conditions Relative to Set Points

Performance data over three months since commissioning in mid-September reveal a successful outcome. While operating 24/7 at 100% outside air:

- Space temperatures always remained within 1°F of the set points
- Space humidity (dew point temperatures) did not exceed 3°F of the set point over 99% of the active cooling period
